# **Learning from Accidents**

**Trevor  
Kletz**

Third edition

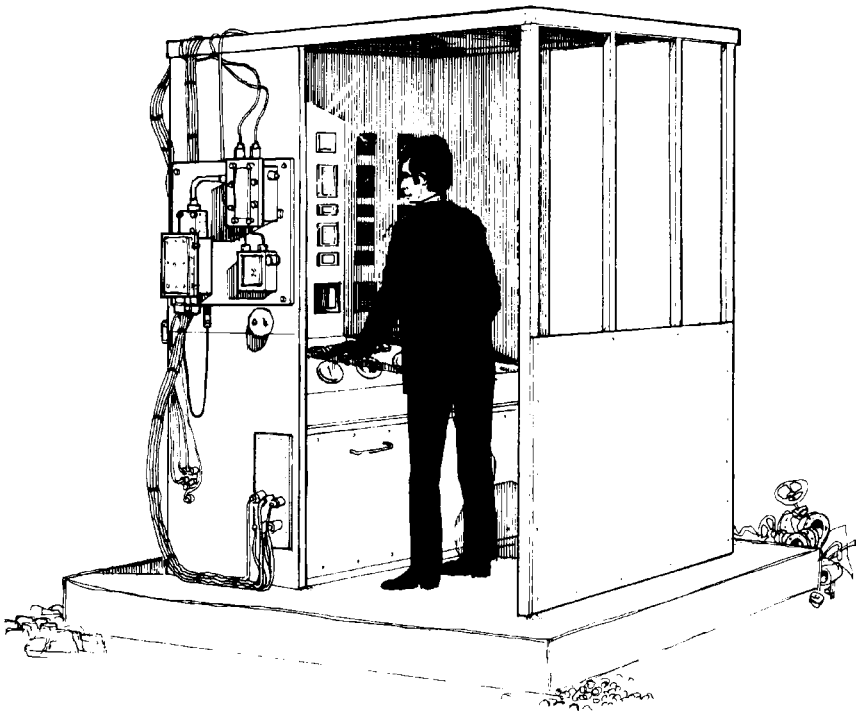
**Figure 2.2** Instruments controlling the drying unit were located in this outdoor panel. Electrical equipment was purged with nitrogen

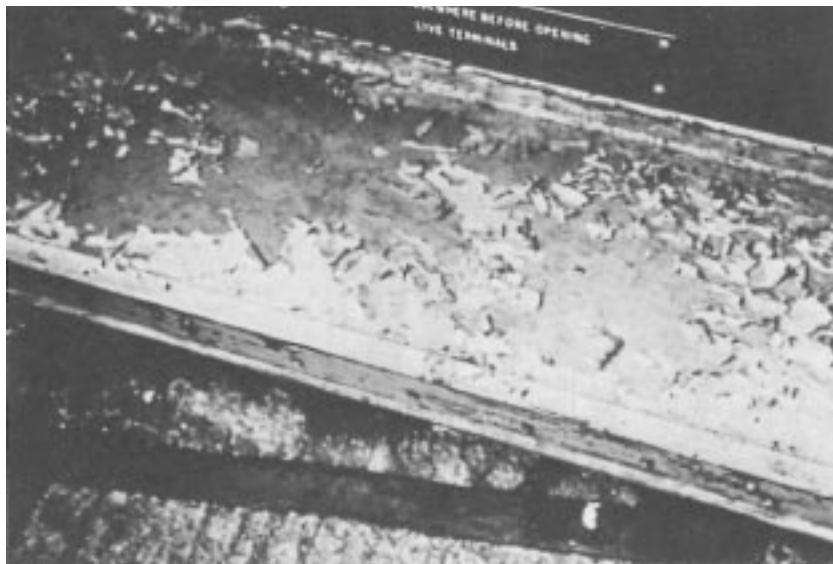
**Figure 2.3** This view of the cabinet's inside shows paint attacked by solvent, suggesting that vapour had been getting in for some time

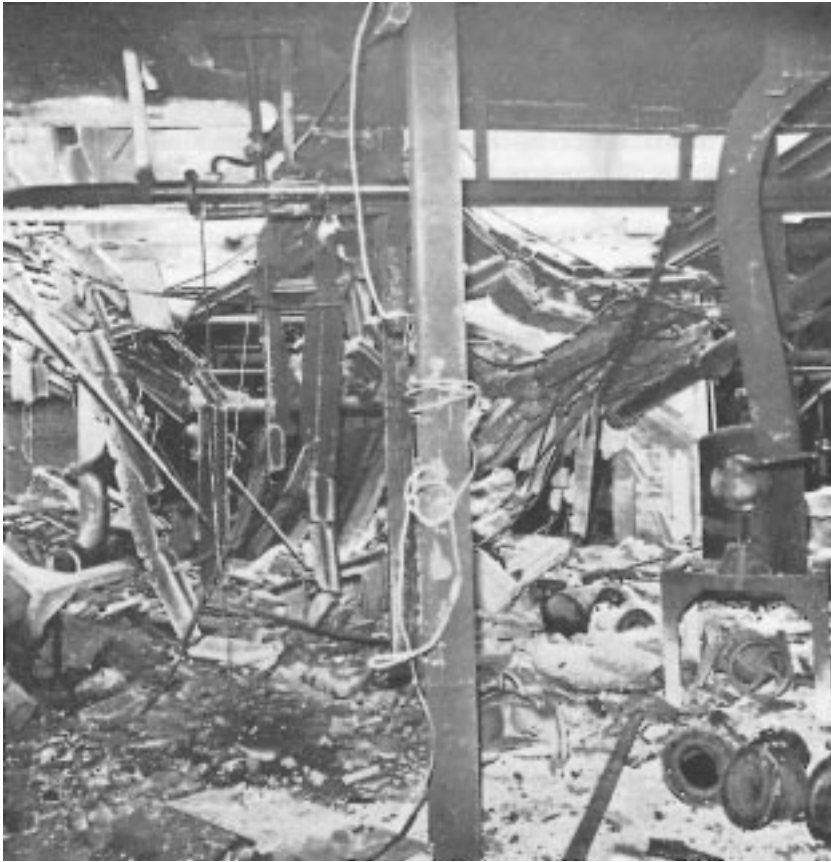
As already stated the leak of ethylene occurred from a badly made joint on a small diameter line, about 1/2 inch (12 mm) internal diameter. The joint was a special type, suitable for use at high pressures and assembling it required more skill than is required for an ordinary flanged joint. Once the joint had been made it was impossible to see whether or not it had been made correctly. It would be easy to say that more care should be

**Figure 4.1** Some of the damage caused by the explosion

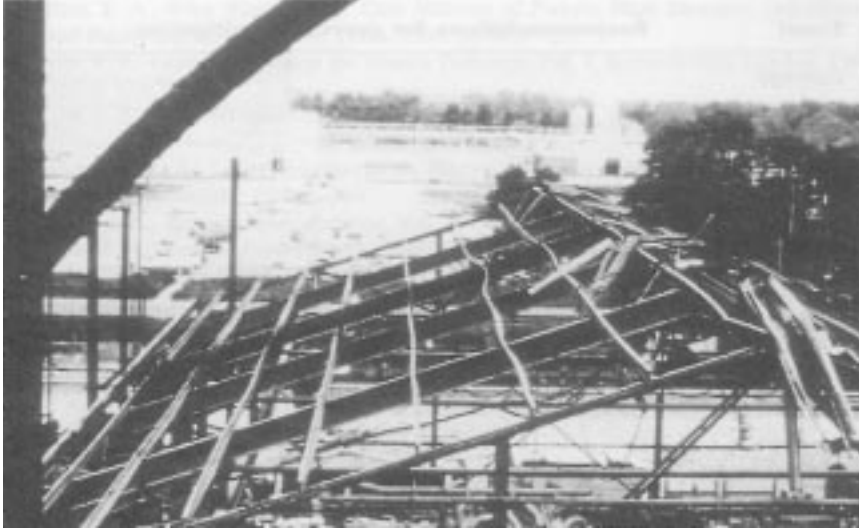
**Figure 4.2** The result of an explosion in a hydrogen compressor house

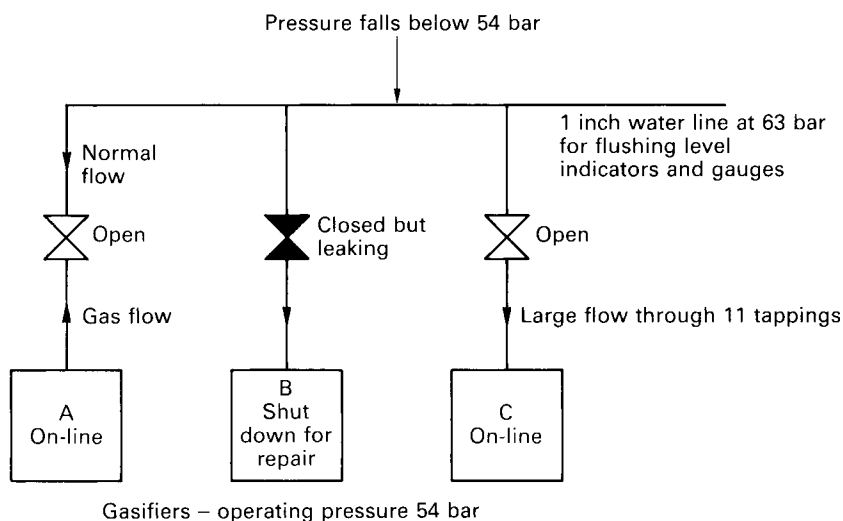
**Figure 5.2** Another accident due to a missing slip-plate. When the pressure in the water line fell, gas from gasifier A entered the water line, passed through the leaking valve into gasifier B and exploded

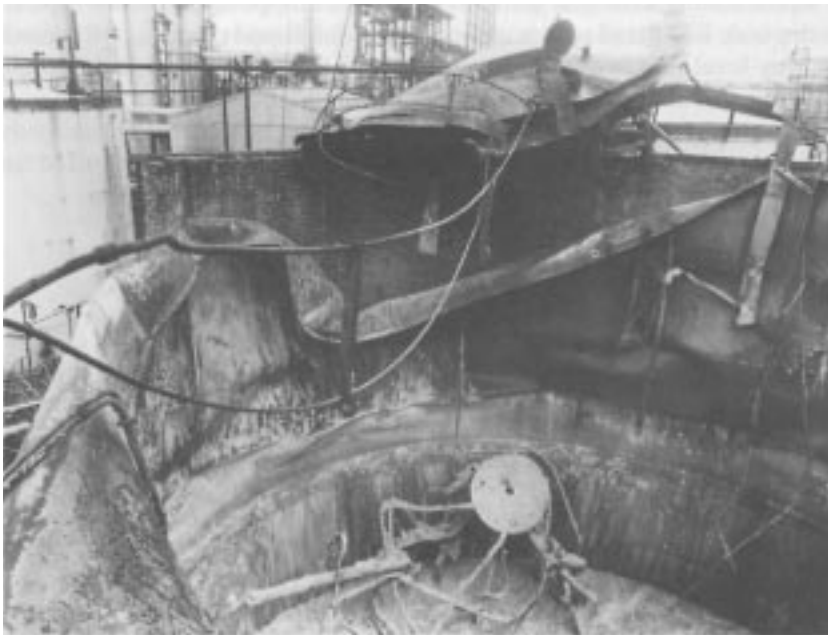
An explosion followed by a fire occurred in a 1000 m<sup>3</sup> fixed roof storage tank which was one-third full of a volatile hydrocarbon (Figure 6.1). The roof was blown off the tank but remained attached at one point. Application of the theoretical quantity of foam from hoses failed to extinguish the fire, either because the foam dried out before it reached the

**Figure 6.1** The inside of the tank after the fire

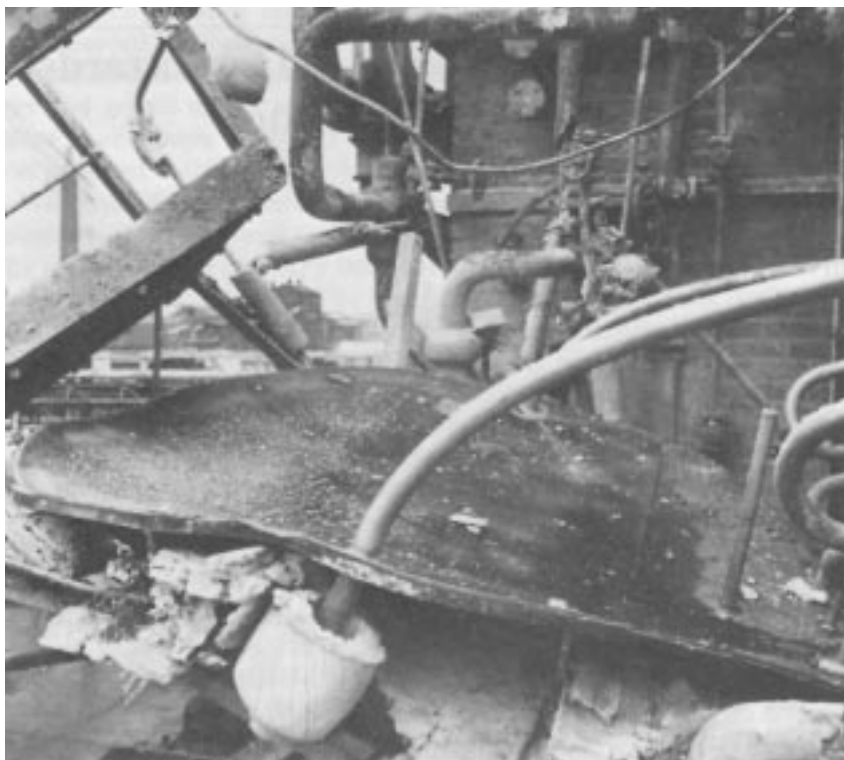
It was later found that the vent was plugged with solidified product. The tank was designed to withstand a gauge pressure of 5 psi (0.3 bar) and would burst at a gauge pressure of about 20 psi (1.3 bar) so in retrospect it is not surprising that the plug of solid was stronger than the tank.

**Figure 7.1** The end blown off the tank by gas pressure

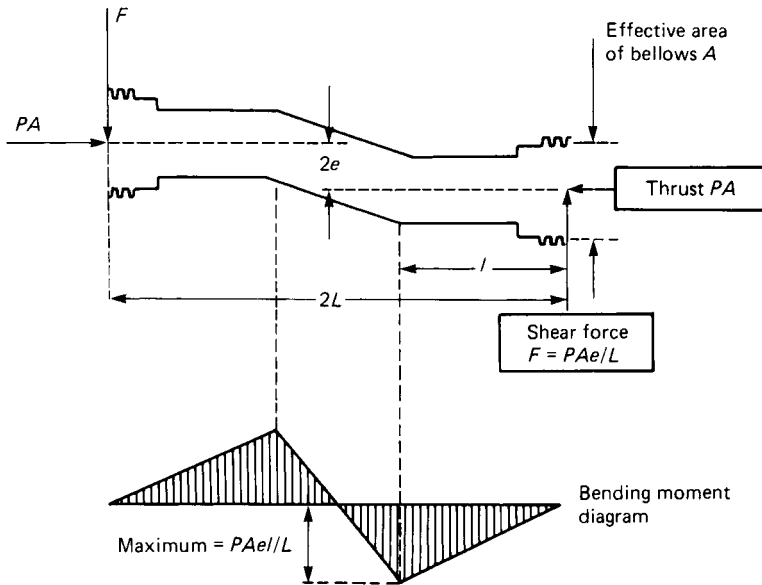
**Figure 8.2** Sketch of pipe and bellows assembly showing shear forces on the bellows and bending moments in the pipe (due to internal pressure only). (Reproduced by permission of the Controller of Her Majesty's Stationery Office)

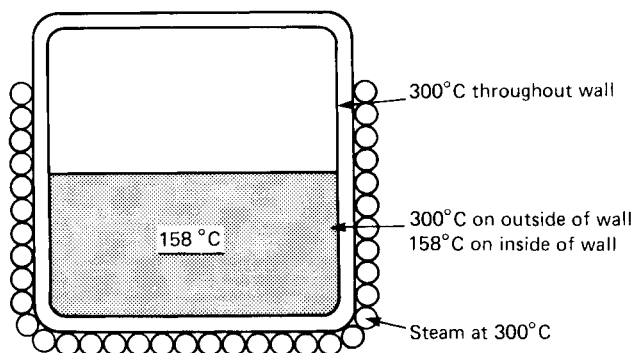
**Figure 9.1** The Seveso reactor. The hot upper portion of the reactor wall heated the surface of the liquid

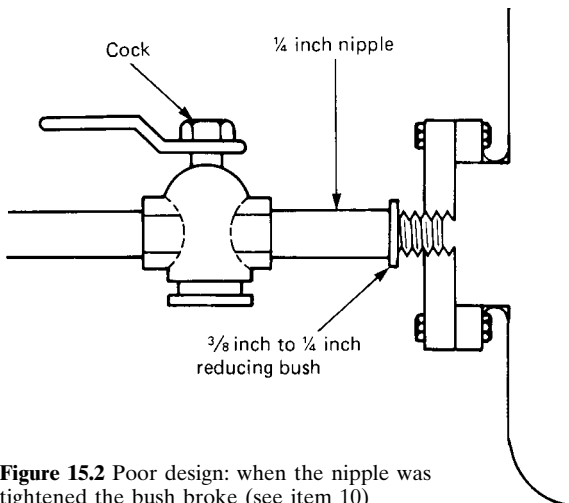
**Figure 15.2** Poor design: when the nipple was tightened the bush broke (see item 10)

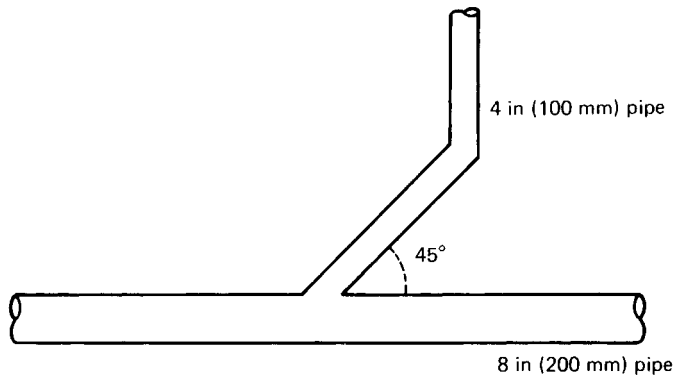
**Figure 16.4** A poorly designed joint which failed, causing a major leak

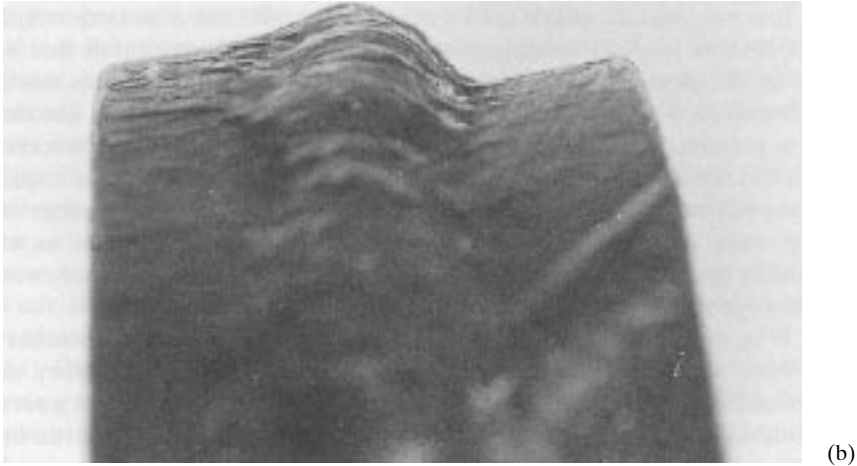
**Figure 16.5** (a) and (b) Two pipes of slightly different diameter were welded together

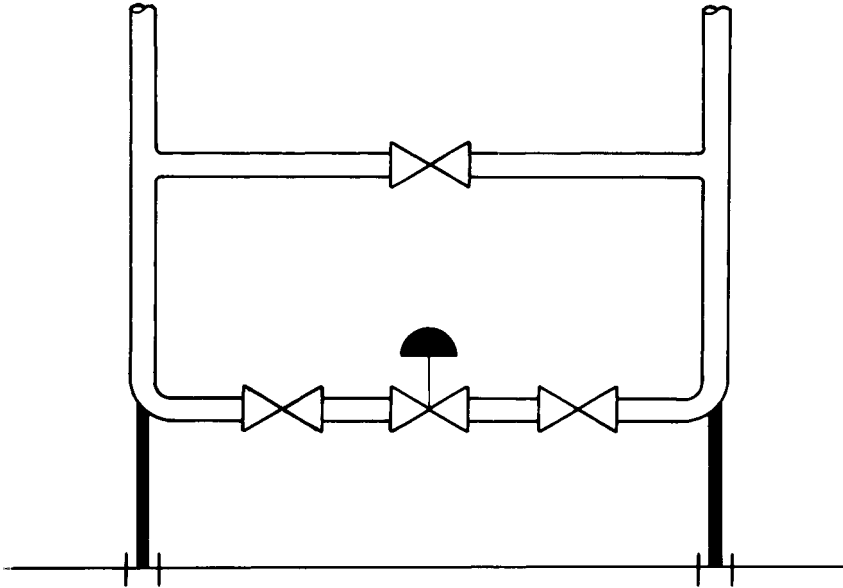
**Figure 16.6** The supports were bolted to the concrete bases and welded to the pipes. When the pipe moved, a piece was torn out

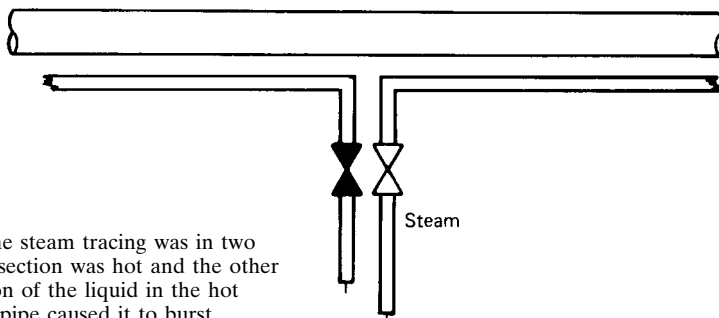
**Figure 16.8** The steam tracing was in two sections. One section was hot and the other cold. Expansion of the liquid in the hot section of the pipe caused it to burst

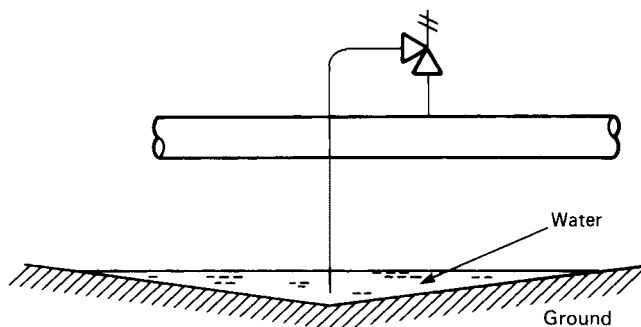
**Figure 16.9** The end of the relief valve tail pipe was so close to the ground that it was below the surface of a puddle and was blocked when the puddle froze

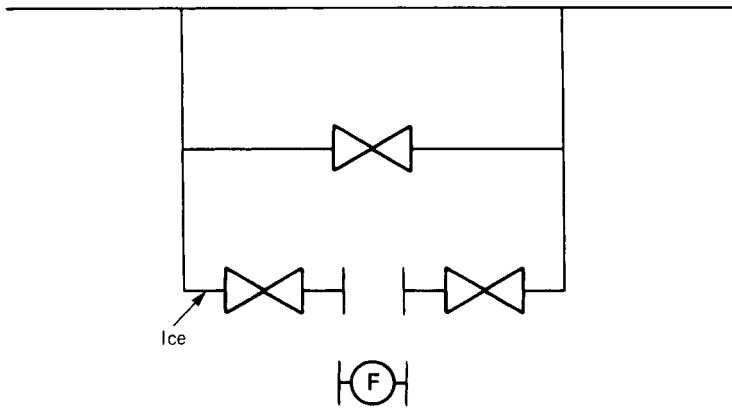
**Figure 16.10** When the flowmeter was removed it formed a dead-end in which water collected

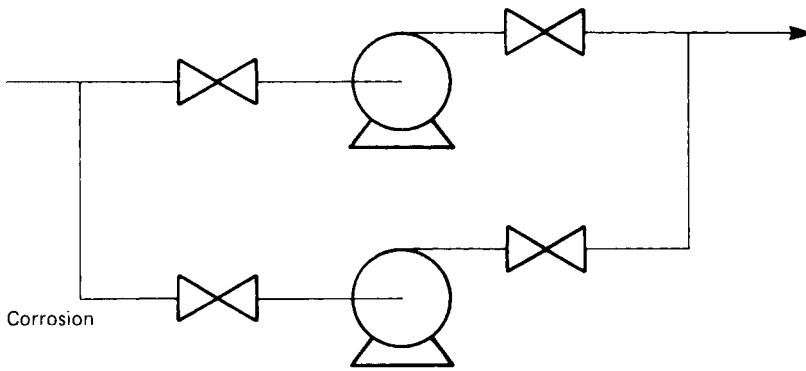
**Figure 16.11** The lower pump was rarely used. Water collected and corrosion occurred

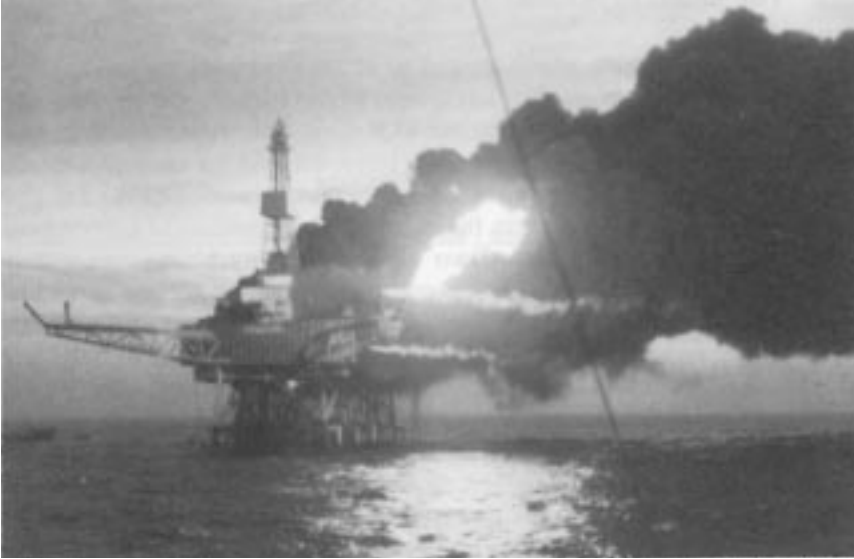
**Figure 17.1** The fire on Piper Alpha during its early stages, before the rupture of the risers. (Copyright: Robert Gibson)

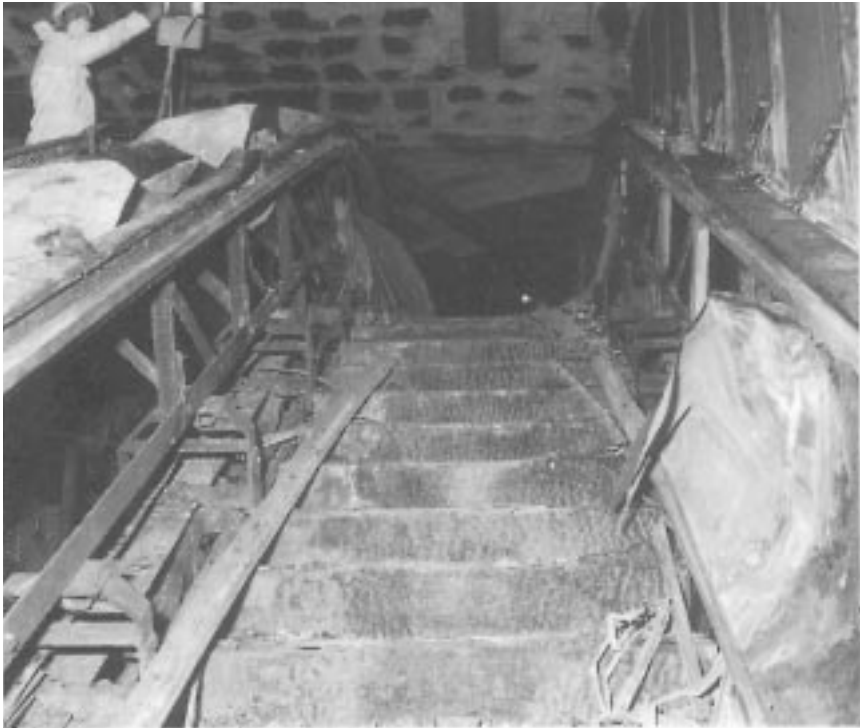
**Figure 18.1** The top of the escalator at King's Cross after the fire. (Reproduced by permission of the Health and Safety Executive.)

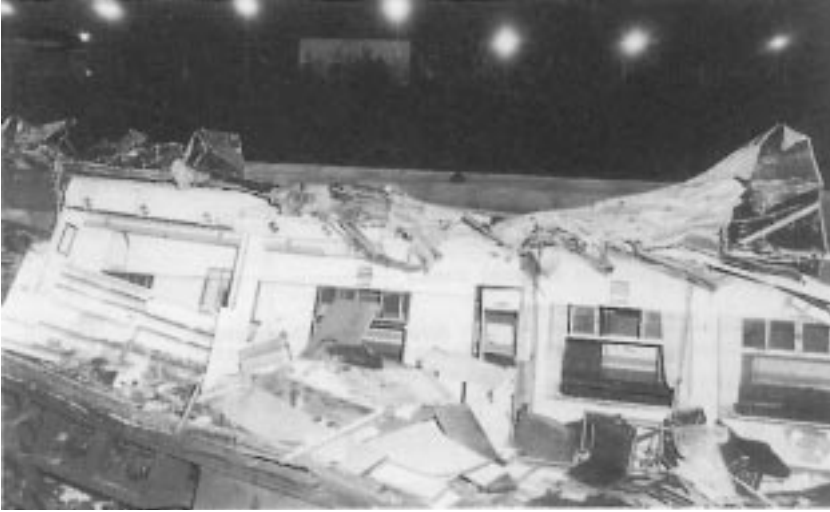
**Figure 19.1** The second coach (buffet car with loose seats) of the second (moving) train involved in the railway accident at Clapham Junction. (Reproduced by permission of London Fire Brigade.)

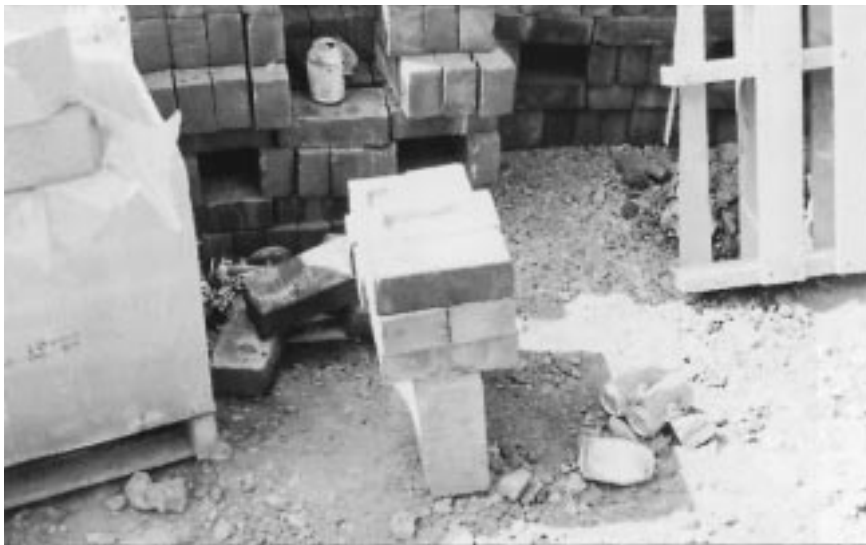
**Figure 22.1** Reconstruction showing how the brick columns were supported on lightweight blocks (Reproduced with the permission of The Controller of Her Majesty's Stationery Office)

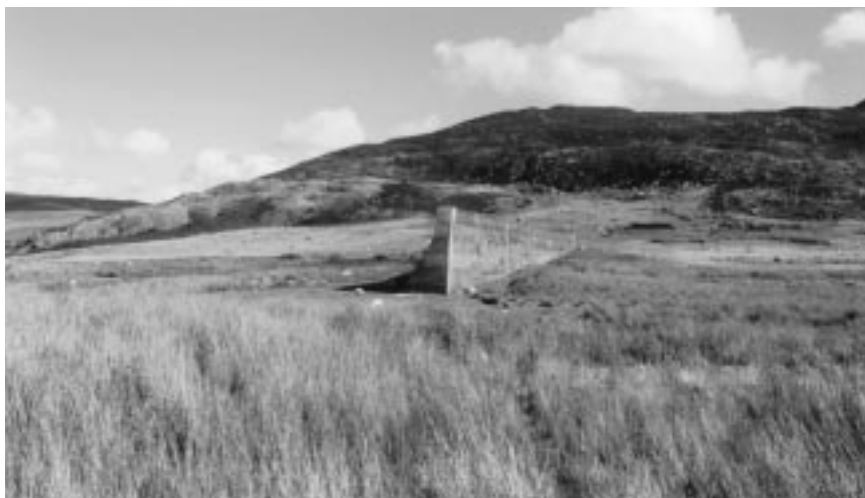
**Figure 22.2** Part of the Llyn Eigiau concrete dam today. The broken end has been straightened

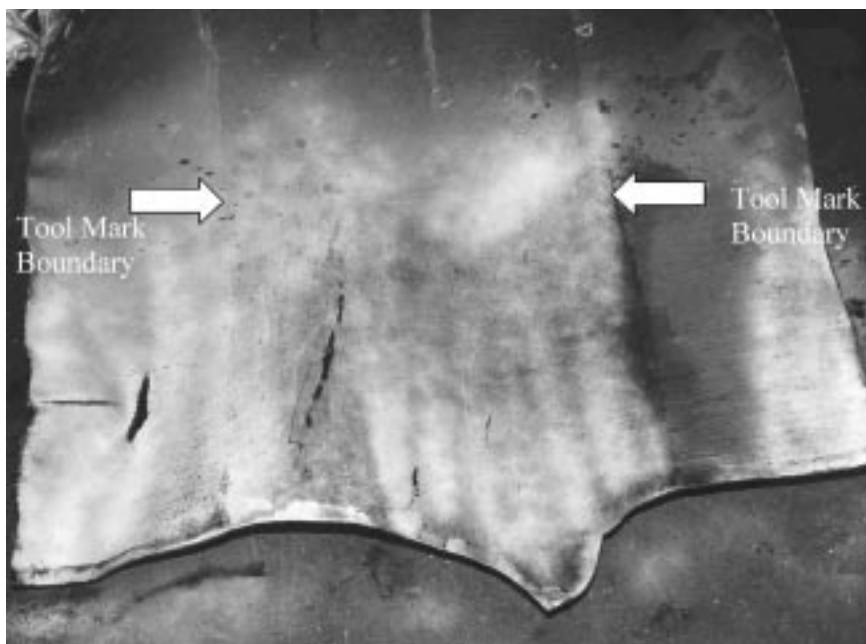
**Figure 28.1** Blown-out section of a 40 bar steam main (Photograph reproduced courtesy of Eastman Chemical Company)

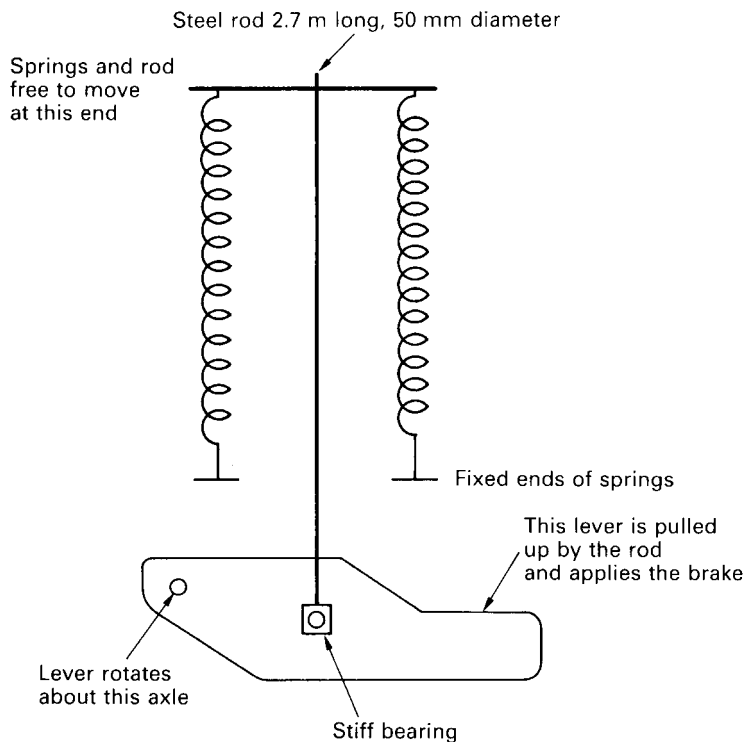
**Figure 30.1** The brake system on the cage at Markham Colliery. The rod was 'single-line' and when it failed the cage fell out of control
